The Columbia Accident: Synopsis of CAIB Report* Regarding the Physical Cause of the Accident and and Personal Thoughts

James O. Arnold, Ph.D

**University of California at Santa Cruz
NASA Ames IPA
Investigator, CAIB, Engineering Group 3**

***Seminar based on CAIB Appendix F2, Vol IV
by J. O. Arnold, H. E. Goldstein and D. J. Rigali**

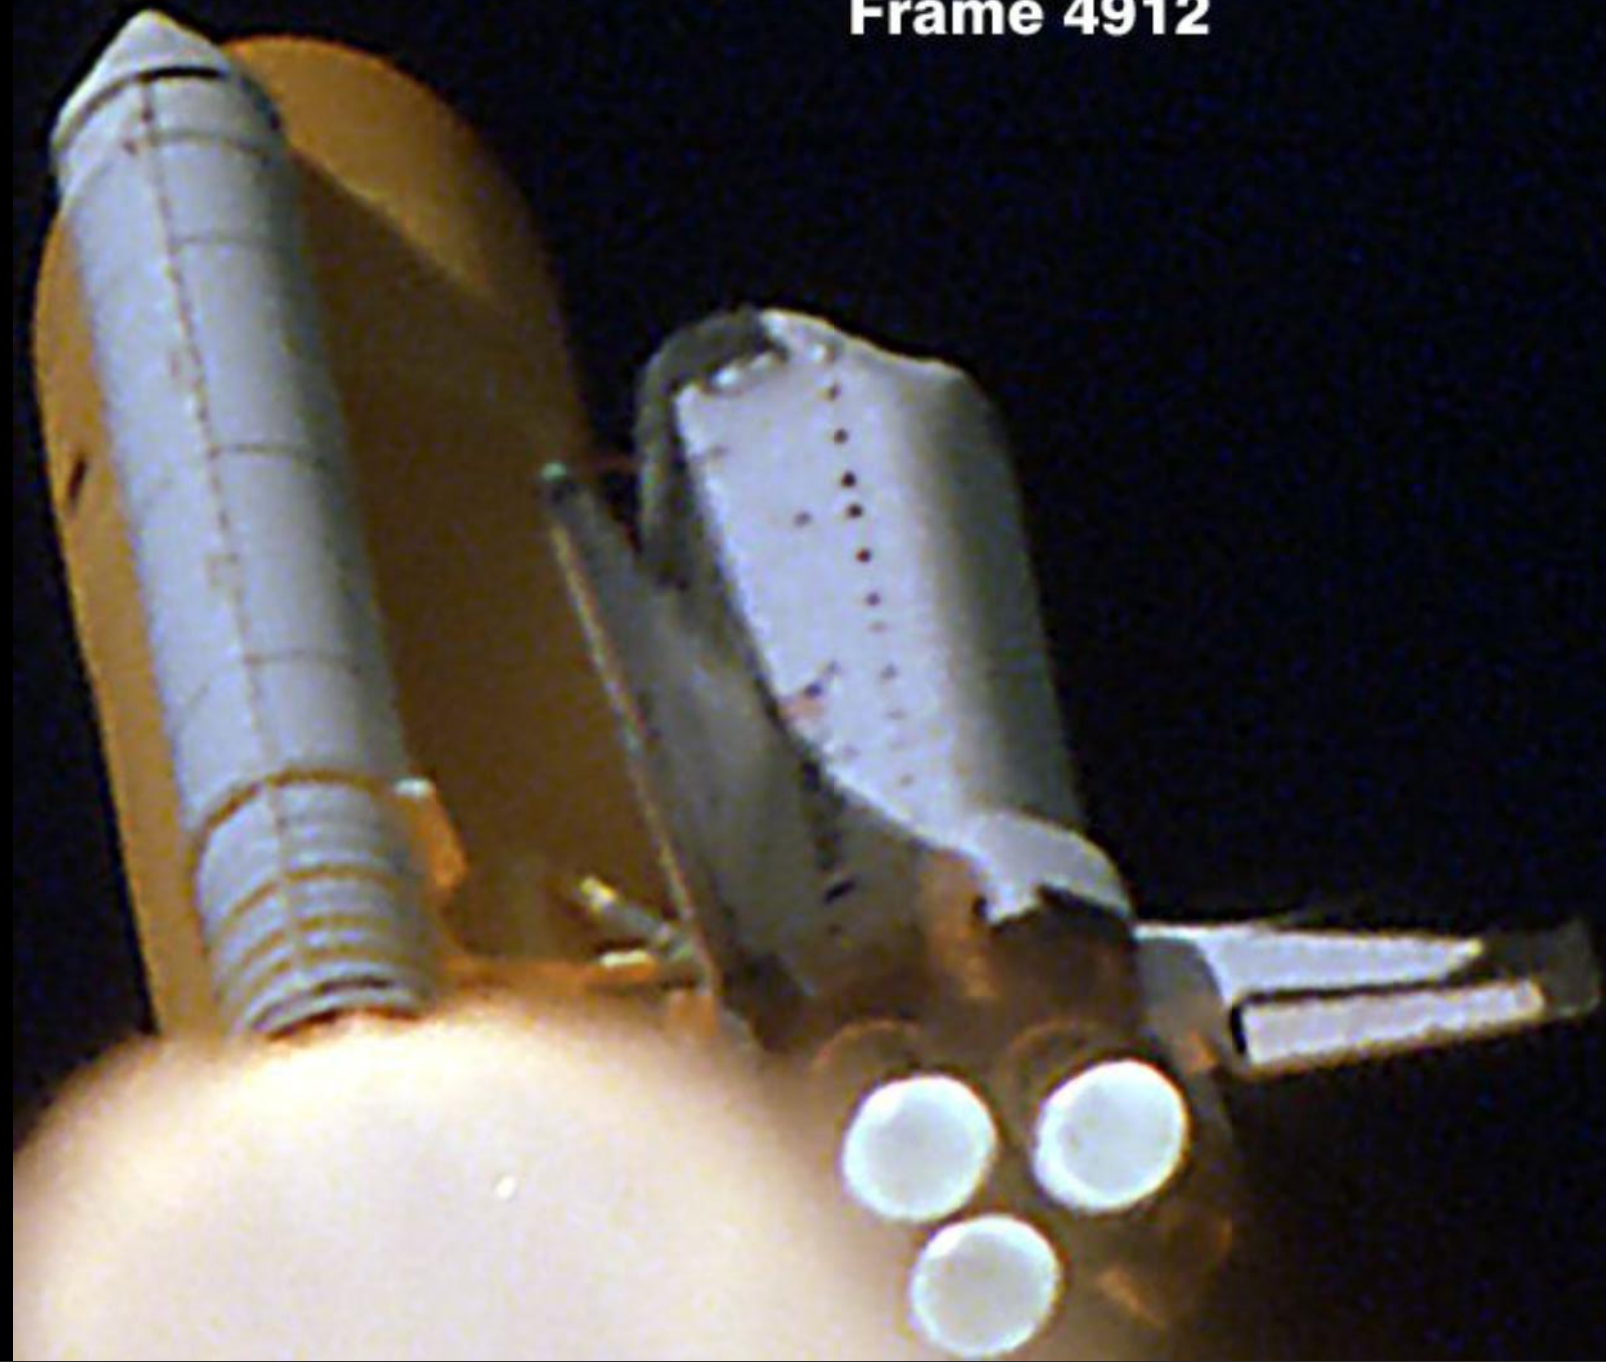
Frame 4912

- Combined background in aerothermodynamics, Shuttle tiles and carbon-carbon
- Knowledge that superheated shock layer gases had entered the left wing box, very probably melting the aluminum substructure, and in essence, sawing the left wing off from the inside-out.
- Very poor quality imagery of the foam strike - no underside view
- Amateur video of entry from California coastline to Texas, including the Starfire photograph taken in New Mexico
- NASA data tracking, but No Orbiter Experiments (OEX) on-board engineering data - this was stored on board on magnetic tape and subsequently was recovered.

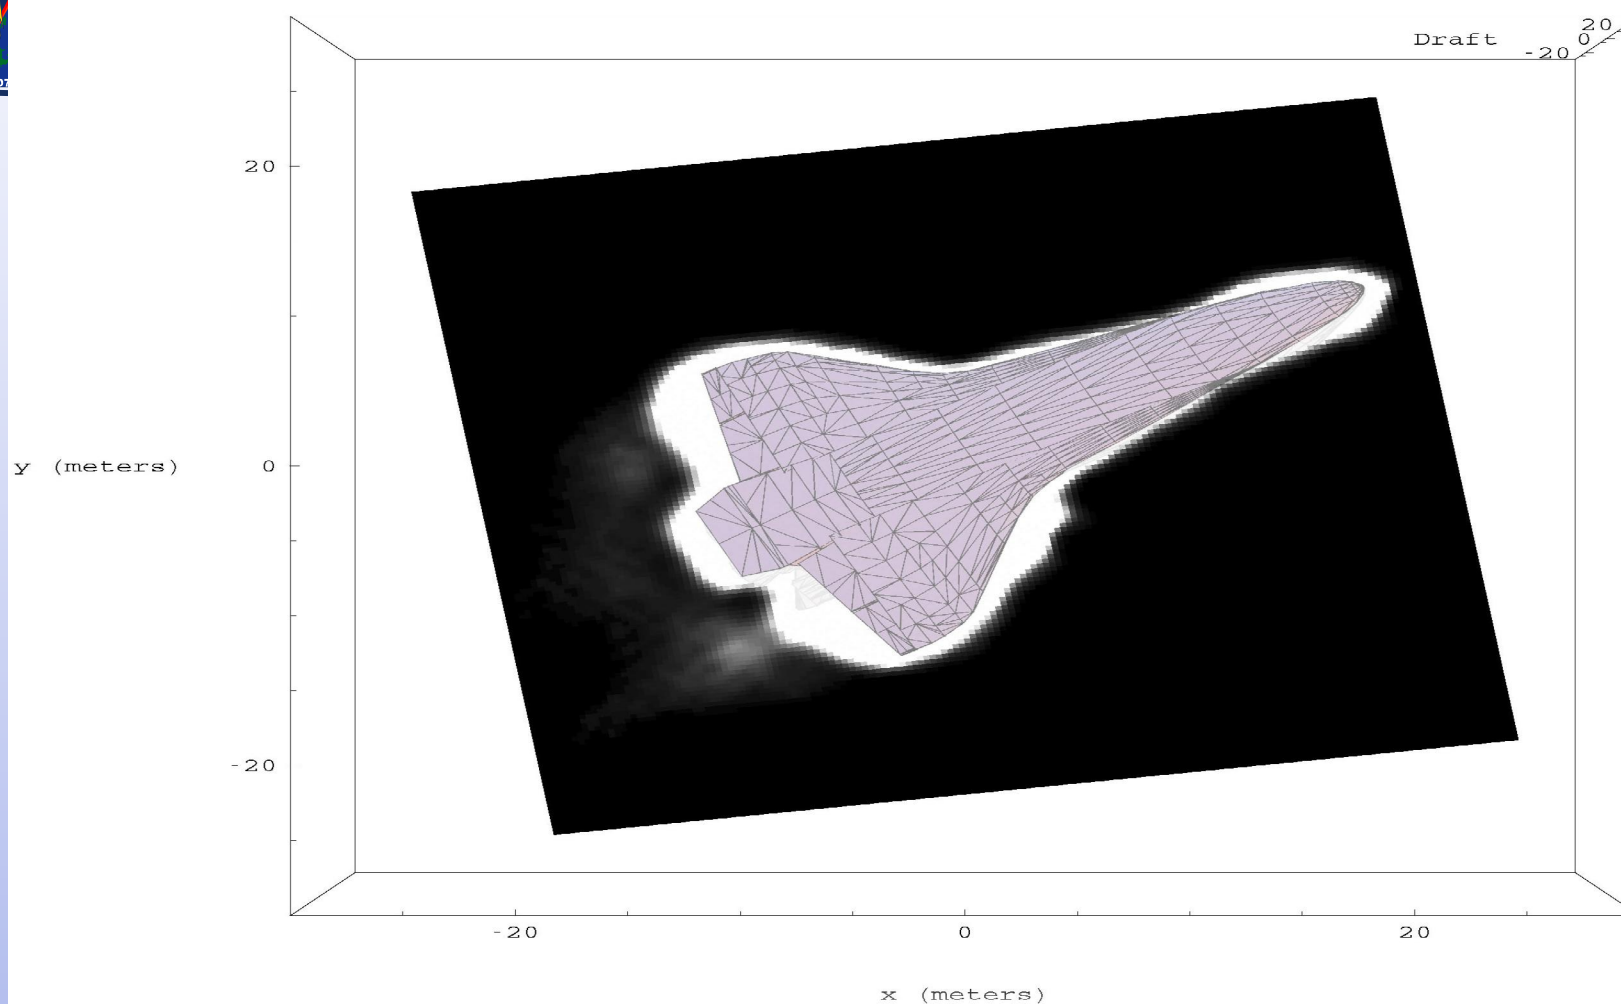
Starfire Photo from Kirtland AFB GMT13:57:14

Starfire Optical Range Image (26 March 2003)
model overlay (R. Cleis, R. Fugate, R. Johnson)
image sharpened using deconvolution (J. Christou)

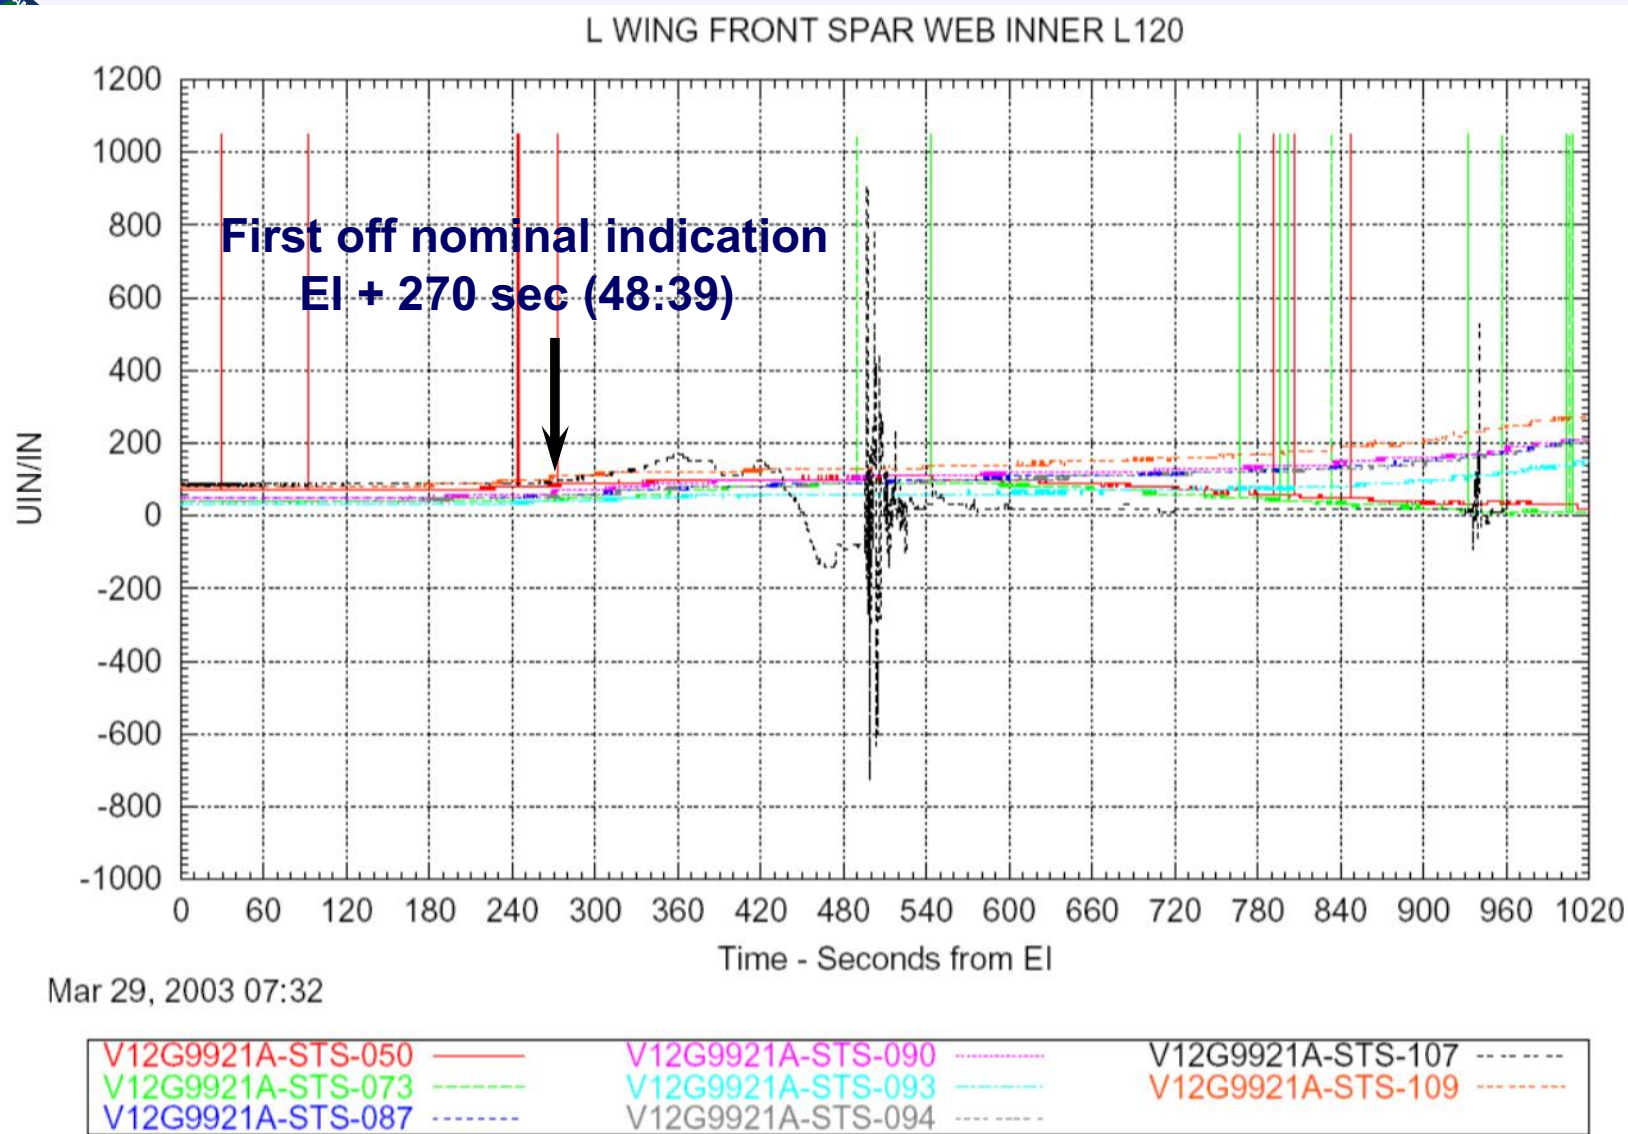
OEX STS-107 Flight Data

- Key Sensors and their locations on the orbiter. Shuttle Columbia was the only vehicle fitted with OEX sensors.
- Out-family sensor readings for STS 107. Tape recorder was recovered from the debris field. By a miracle, the tape was OK.
- Time-line of sensor readings and interpretation

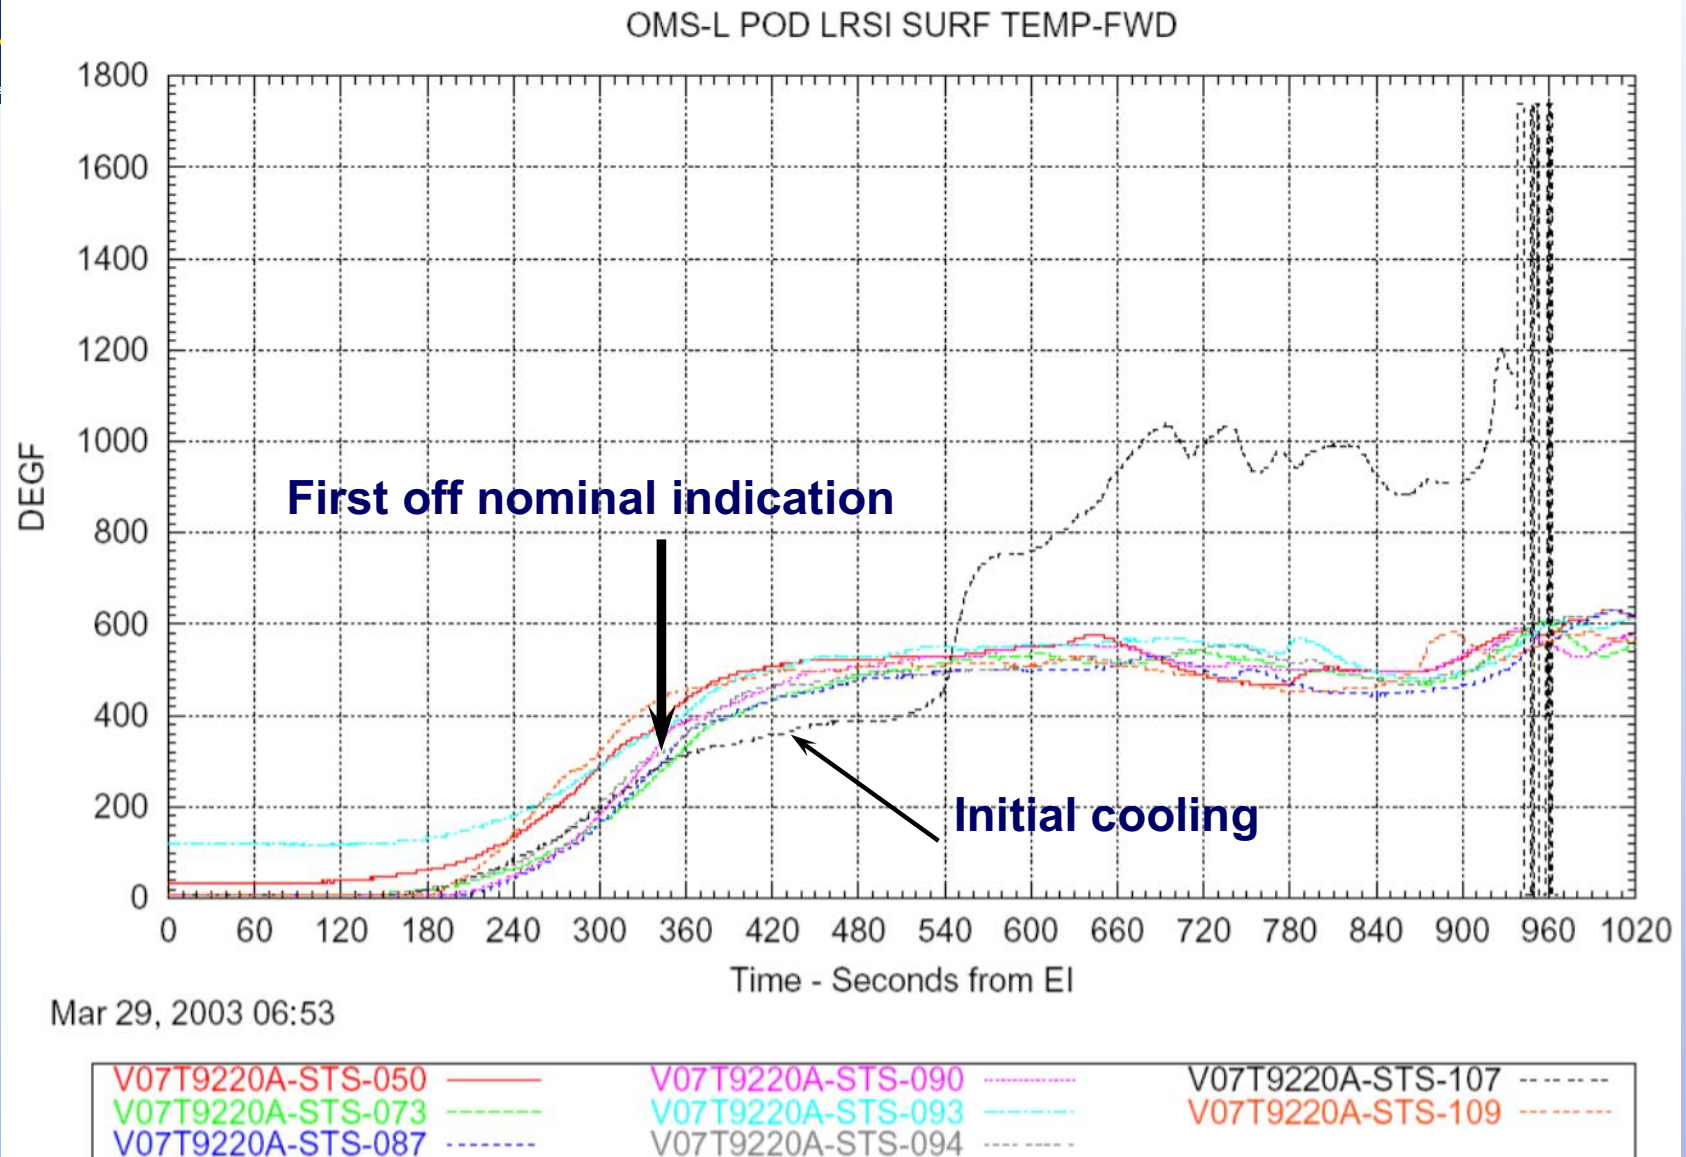
“Typical” Off Nominal OMS Pod Temps.

LaRC Wind Tunnel Tests Data help explain cooling trends on OMS pod

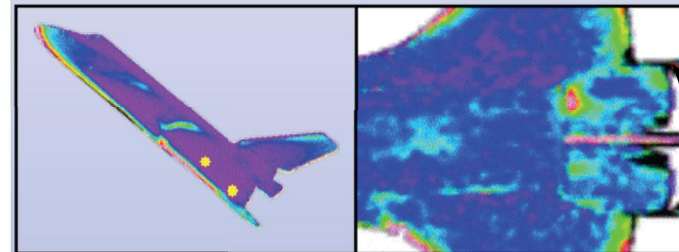
Missing panel #5

Wing leading edge damage influences leeside flowfield

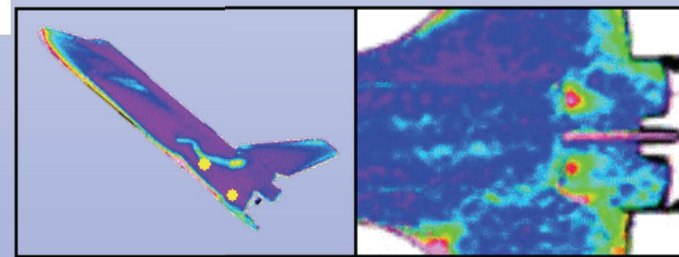
Missing panel #10

Note cooling trend on left OMS pod

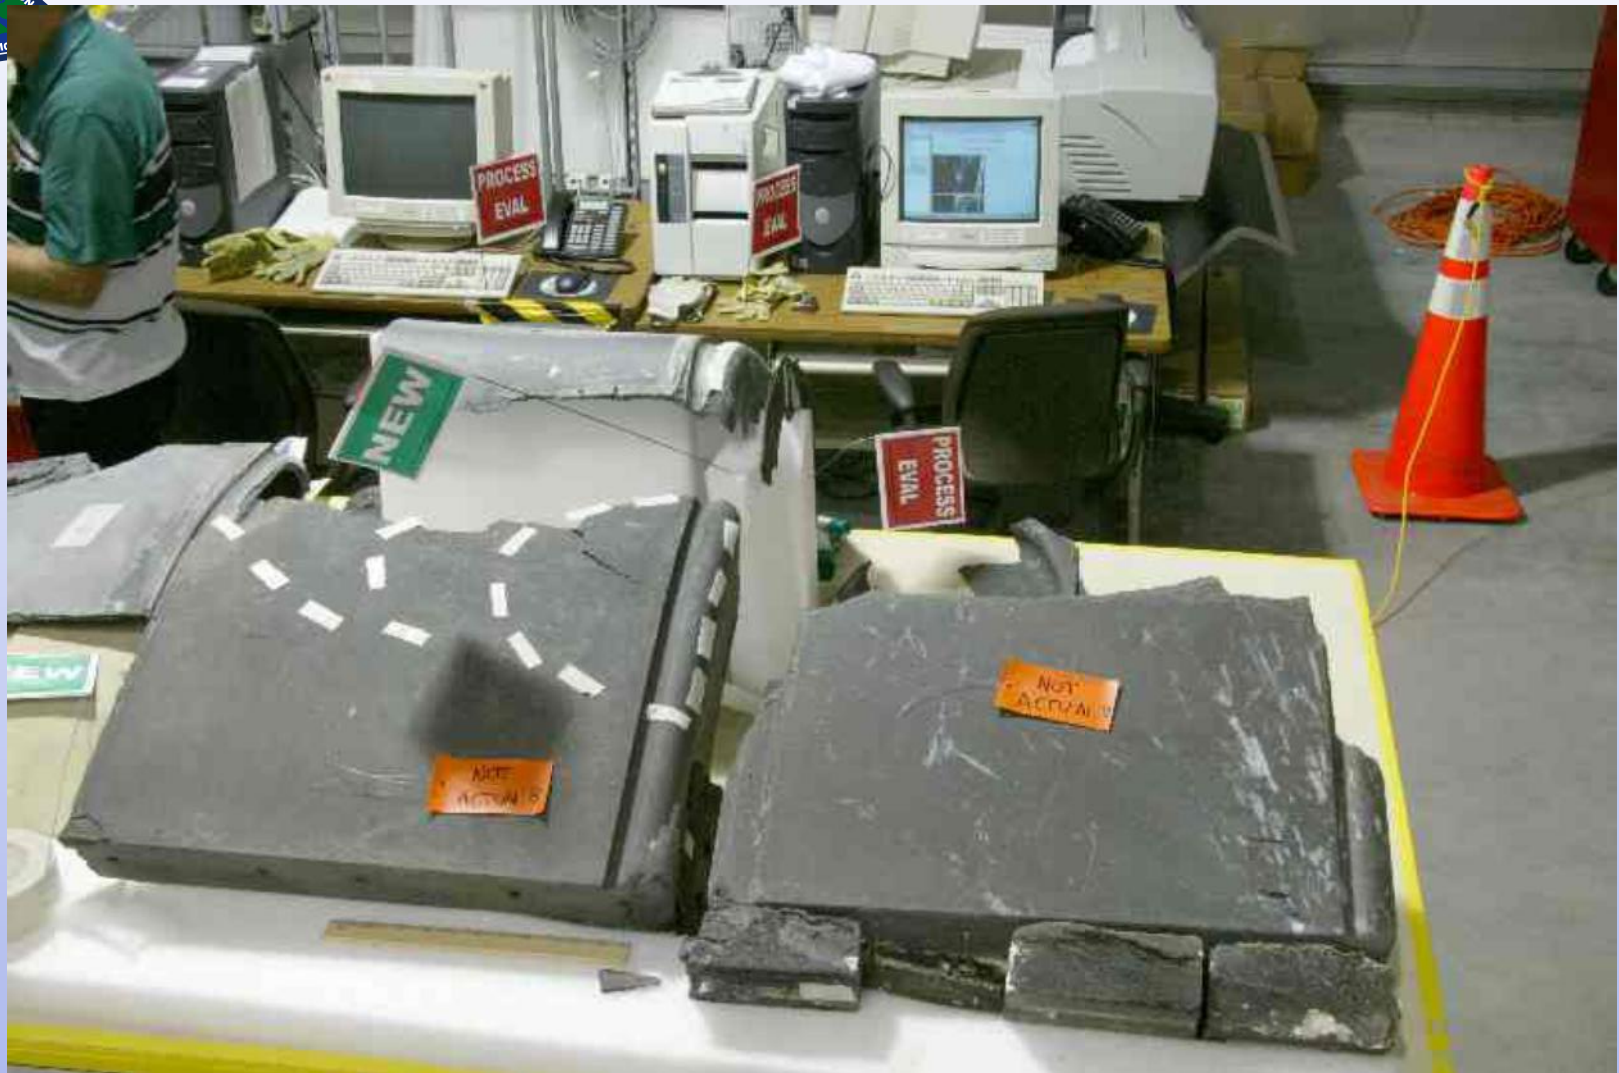
Probable Initial Breach in Panel 8

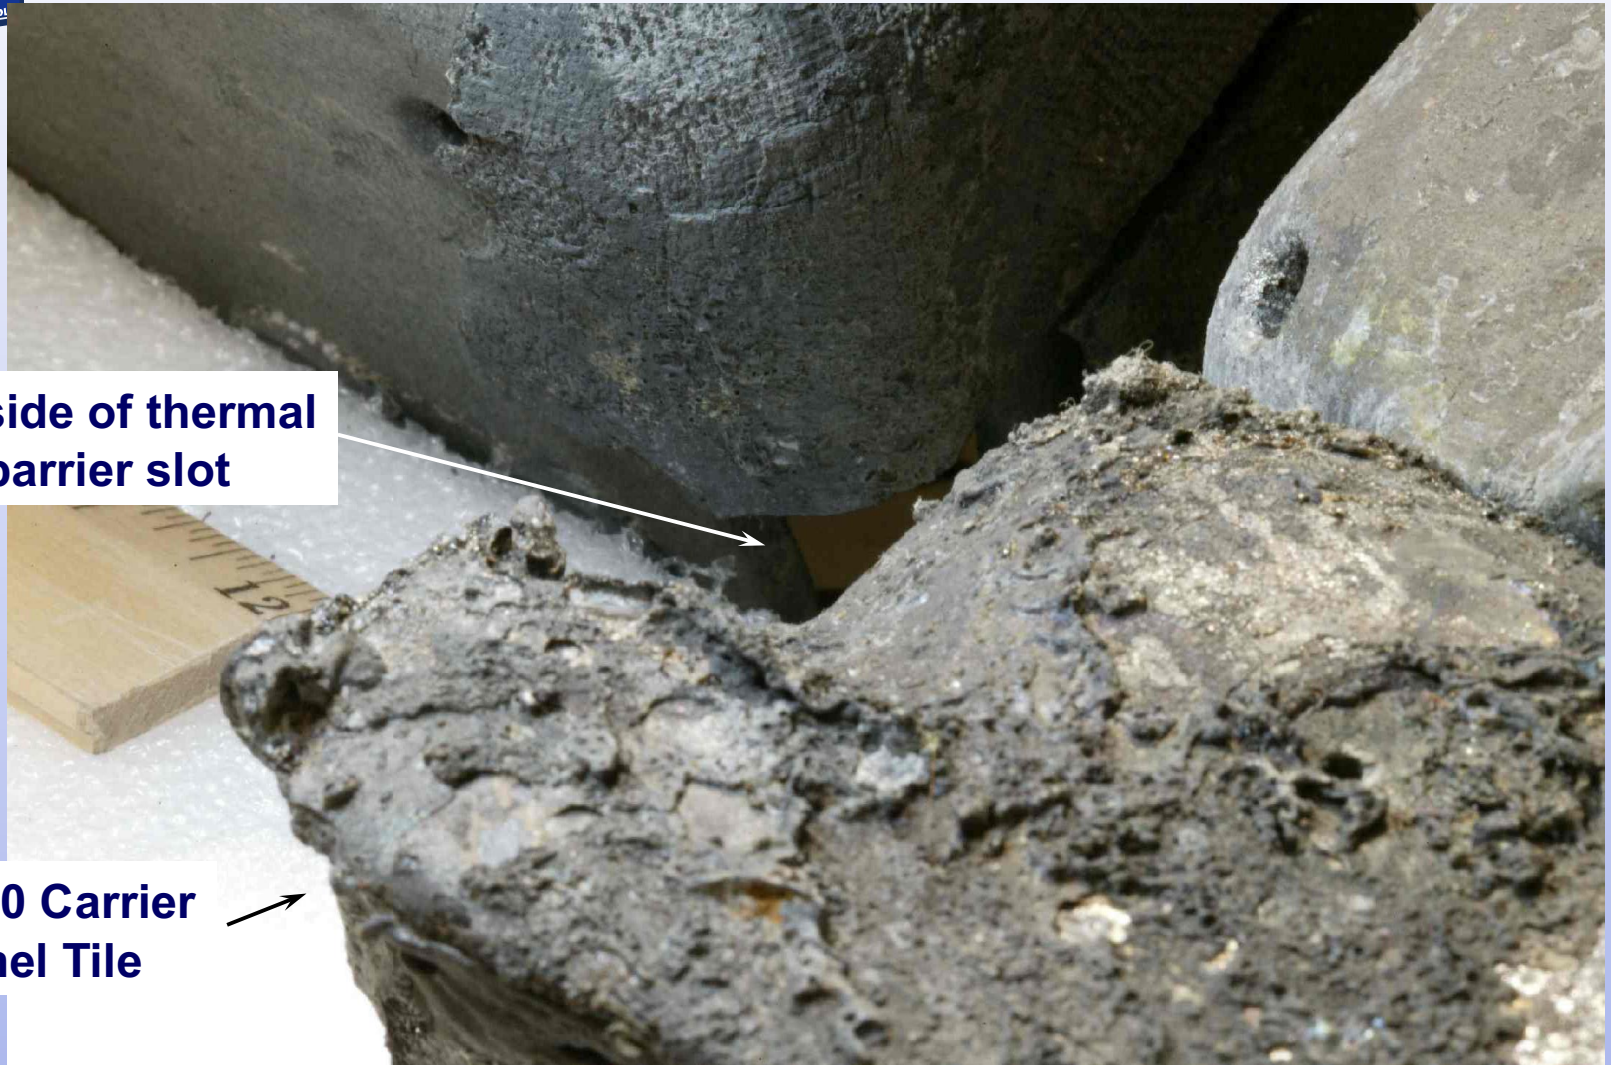
Close up of lower edge of panel 8/9

Outside of thermal
barrier slot

LI 2200 Carrier
Panel Tile

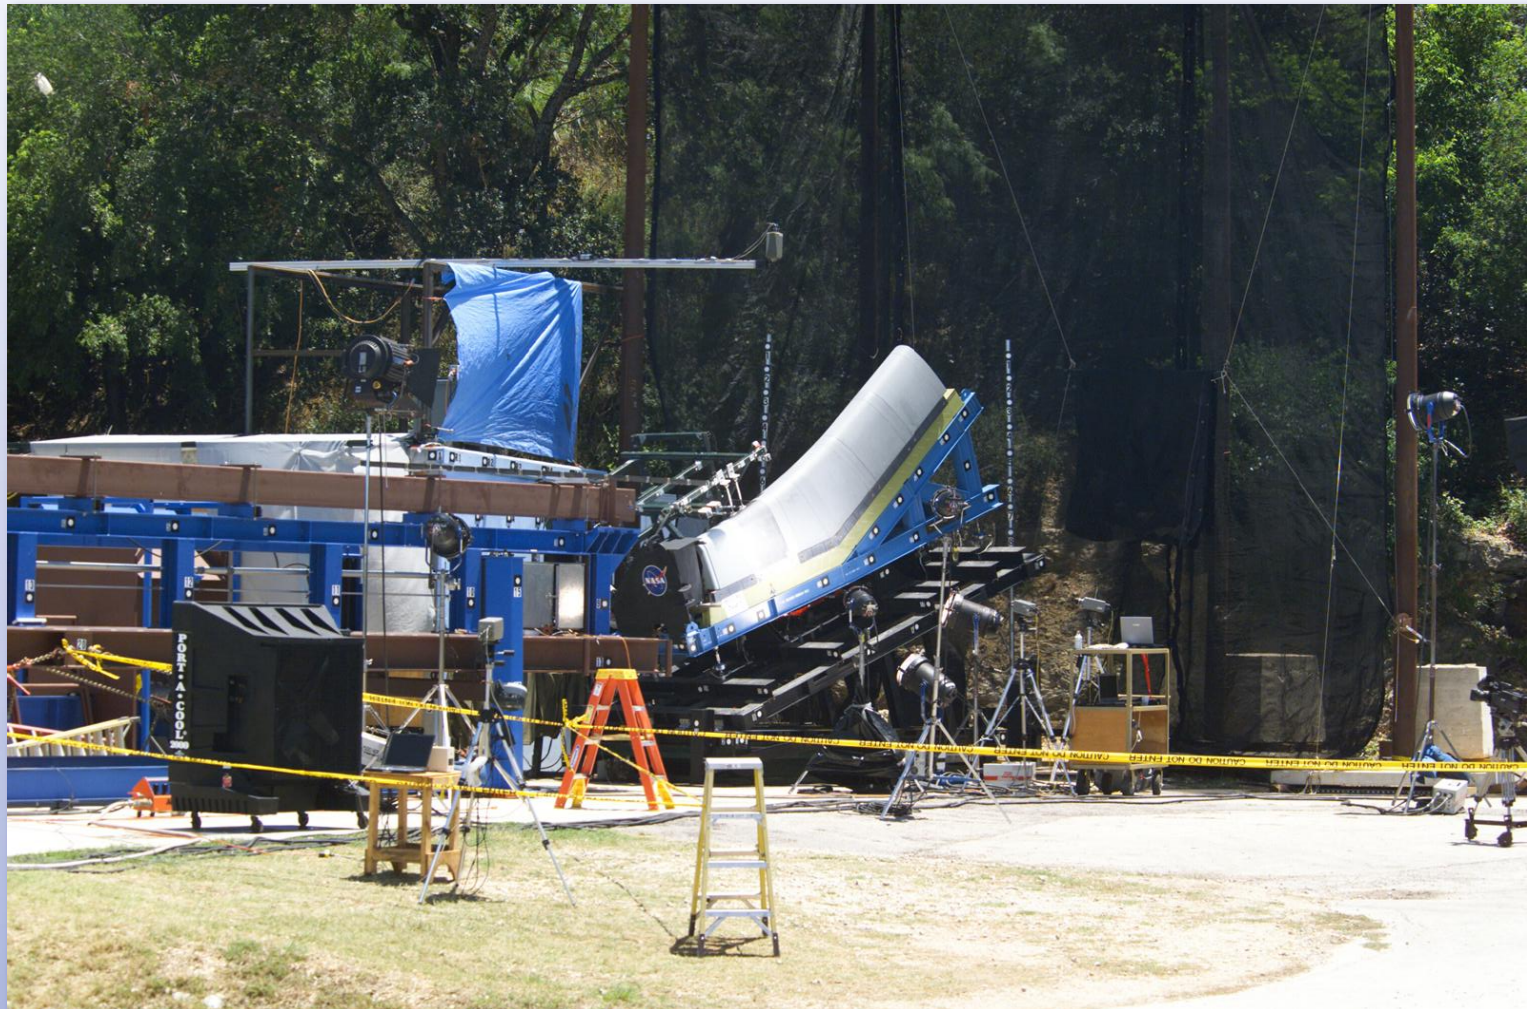
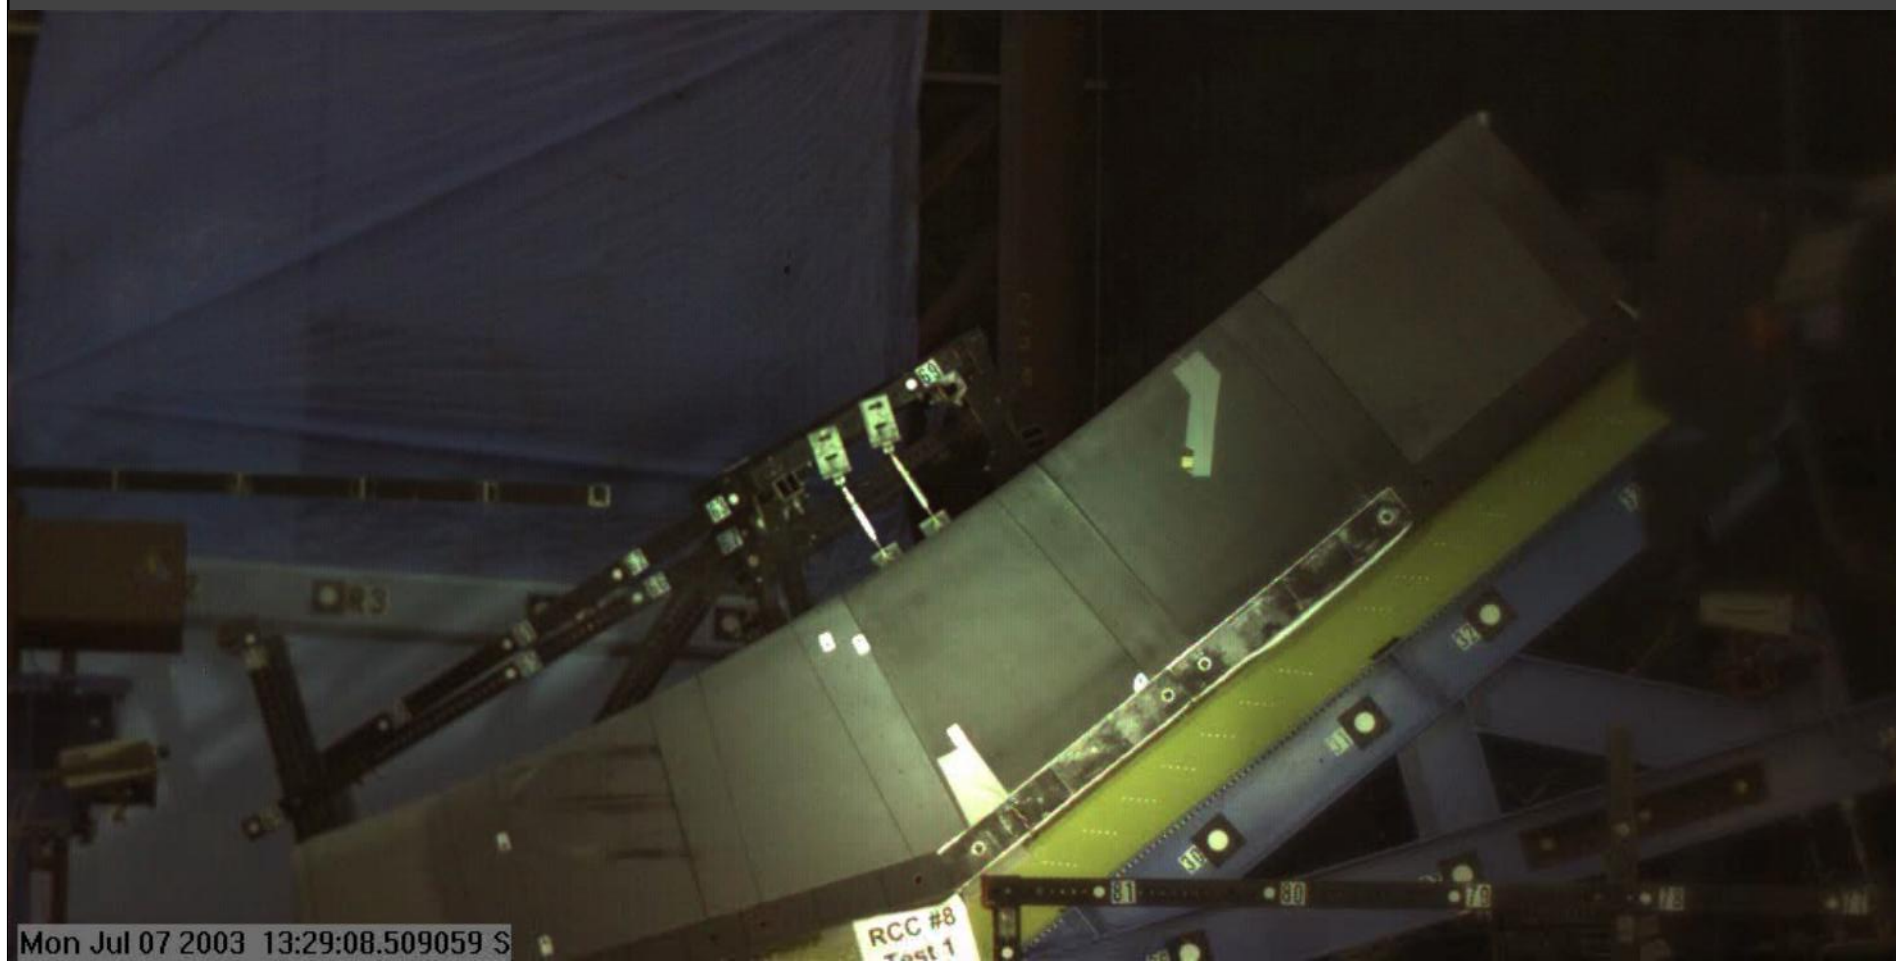
Wing Leading Edge Test Set Up

- CAIB lead: G. Scott Hubbard. Paul Wilde (CAIB) was lead on “Follow the Foam”. Large modeling effort led by JSC NASA and included work by Sandia
- Tests on tiles conducted first, little damage
- Then tests on fiberglass simulating RCC
- Tests on actual, aged RCC in one-for-one ground test
- Conclusive evidence that foam impact was initiating event
